Assessment of Major Bridges Along Nasarawa, Plateau, Bauchi and Gombe State Highway, Northern Central, Nigeria

Mlanga Victor Musa Kyauta Ekpo Ekpeyong Alhassan Iko David

Nigerian Building & Road Research Institute, 10 NBRRI Road/ I.T. Igbani Street, Jabi District, Abuja, FCT, Nigeria

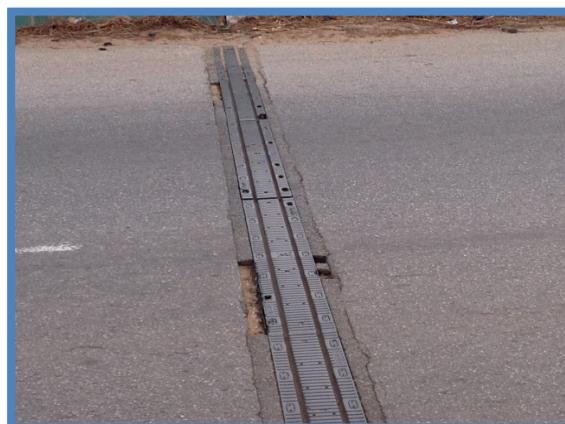
The Uke Bridge is located along Abuja-Keffi expressway on coordinate N08° 54.742' E07° 42.803' of the prime meridian. They each have 2 lanes. It was observed here that some deck expansion joints are deteriorated and leakage has been observed at the joints and the surrounding concrete. There is major spalling of bituminous wearing course at the adjacent decks near the joints. Also the stone pitching done to the embankments has partly dislodged due to poor concrete mix, allowing vegetation to grow and run off to then erode the slope. Several pile caps have become exposed and are vulnerable to scouring which would lead to exposure of the piles and weaken the pier supports. Concrete spalling 3 inches deep was observed on one of the piers. This has led to rebar exposure and loss of section. The exposed reinforcement bars can be seen to be undergoing corrosion due to the presence of water. Debris was observed to have lodged and settled between the girders on the pier caps due to deck joint leakage. This has encouraged unwanted vegetation growth which can limit longitudinal and lateral movement of the beams and lead to deterioration of the elastomeric bearings. Fig. 2.

Figure 3a. Deteriorating expansion joint

1. There is need for replacement of numerous expansion joints and resurfacing of the wearing course around the joints.
2. Re-fill and compaction of backfill, rehabilitation of stone pitching on the embankments that have eroded and the application of any slope stabilization technique where it is needed but absent.

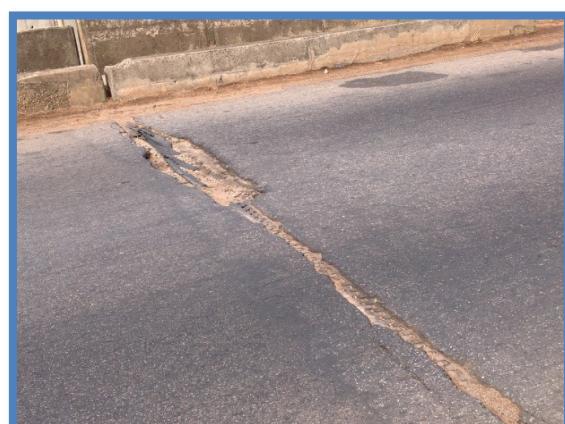
Figure 3b. Deteriorating expansion joint.

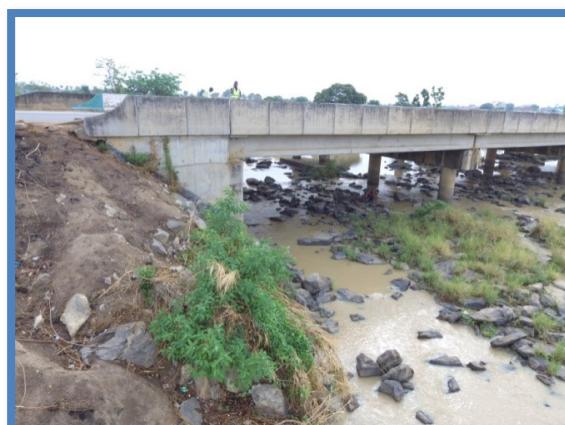
Figure 4. Dislodged stone pitching
Source: Field Survey 2019

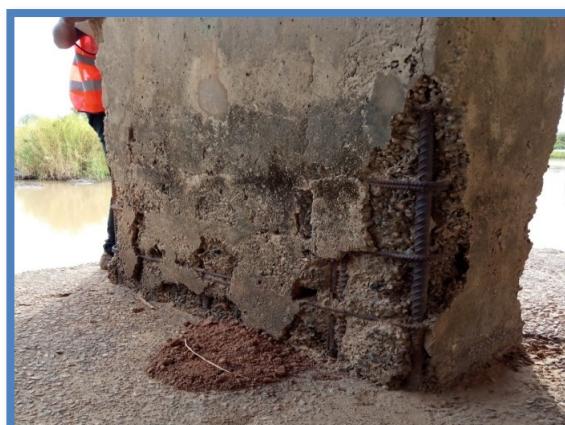
Figure 5. Exposed rebar with section loss

3. Installation of gabion baskets to protect and support exposed piles.
4. General repair of concrete members that have undergone extreme cracking/spalling or section loss and have exposed rebar. This requires the removal of loose concrete and aggregate, cleaning of the concrete surface and rebar, then use of epoxy to bond new concrete to the existing concrete surface. Fibre-reinforced plastic (FRP) may also be used to increase strength and durability of the repaired section.

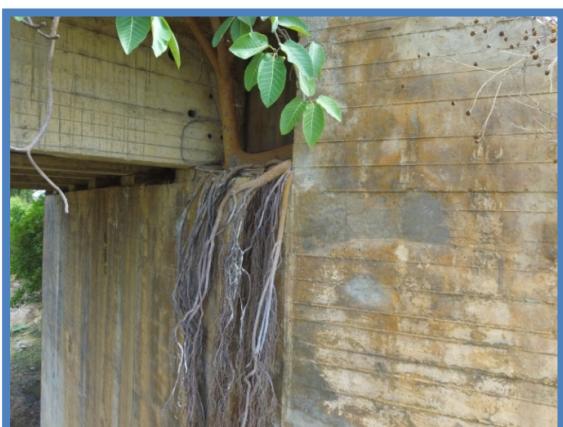
The stem wall from the Akwanga approach has a pronounced crack starting at its top and proceeding down to the bottom of the abutment. Its wing walls also have noticeable cracks. The team of engineers concluded that the stem wall has insufficient thickness and was poorly designed to withstand the cumulative weight of the backfill, bridge superstructure and traffic load. A tree was also observed to have grown on the bearing seat of the same abutment as shown in figure 7.

Figure 7. Tree growing on abutment seat.

5. General sanitation of the girder bridges; removal of silt, refuse and debris from bridge components and bridge premises.
6. Removal and clearance of unwanted vegetation and trees from bridge decks, fascia, pier caps, abutment seats and embankments.

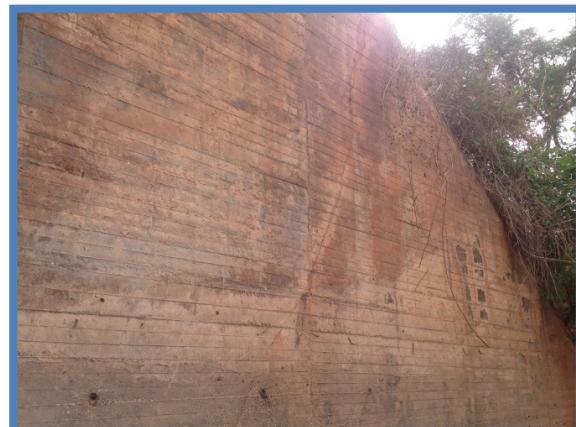
Figure 8. Pronounced crack on wingwall.

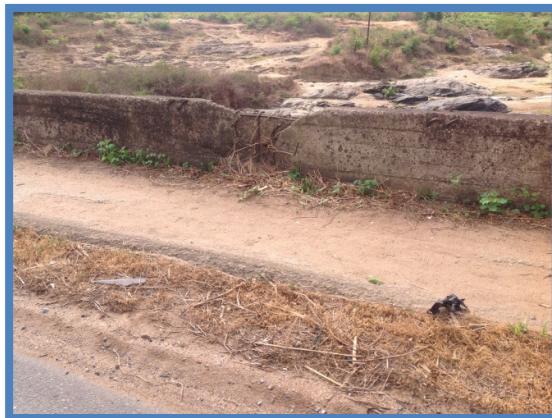
Figure 9.Major spalling of crash barrier
Source: Field Survey 2019

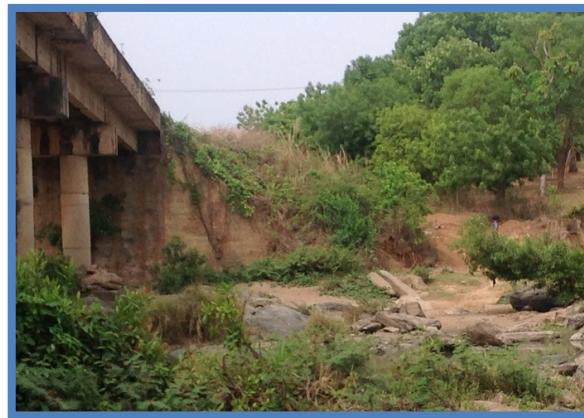
Lastly, the engineers observed that the embankments of the bridge had been left unprotected without stone pitching or any other erosion-preventive treatment. Thus erosion and landslides due to runoff have removed much of the embankment backfill and trees have grown directly behind the wing wall.

Figure 10.Unwanted vegetation on embankment.

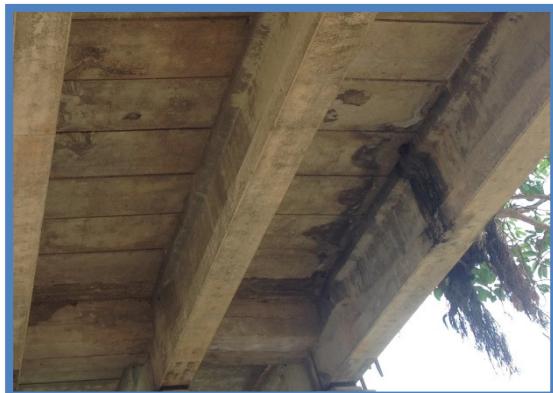
The Mada River flows under this bridge. On the bridge deck, major spalling is occurring on the headers adjacent to the expansion joints and debris has infiltrated the joints. Railings are also missing due to vandalism. This bridge has two large trees growing on the bridge fascia. The team of engineers observed that some drainage pipes on the deck are blocked and this has led to water being stagnant on the deck during rainfall. This has encouraged the growth of the trees.

Figure 12. Blocked drain and tree growth.
Source: Field Survey 2019

7. De-silting of drain pipes and installation of drain filters and seals where necessary.
8. Re-installation of missing railings.
9. Removal of decaying formwork still in place under the soffit and of the sides of the girders of the Gwanje Bridge.

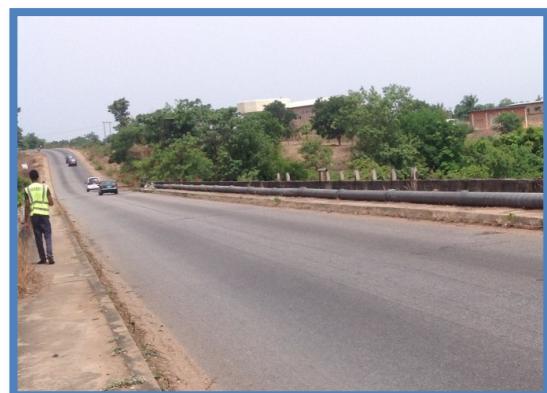
Figure 13. Missing railings due to vandalism

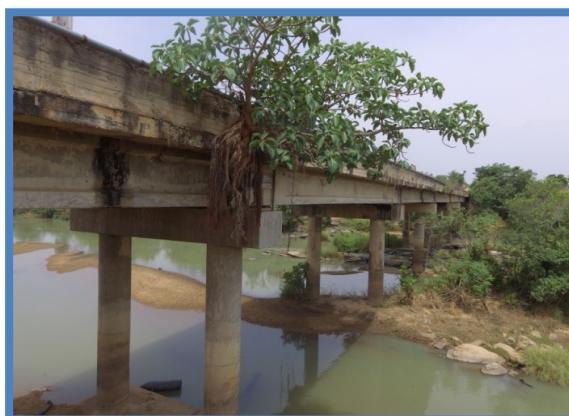
Figure 14. Tree growing on bridge fascia.
Source: Field Survey 2019

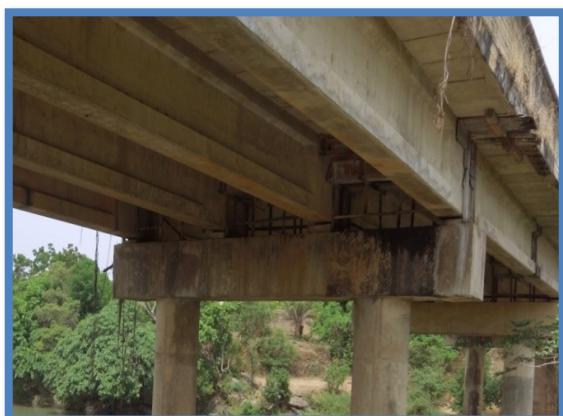
At some expansion joints under the soffit of the deck and also on the sides of the girders, decaying formwork is noticeably still in places years after the conclusion of the structure. This has led to the debris being lodged in the expansion joints, limiting movement of the bridge. Concrete spalling under the soffit of the deck is noticeable around these areas due to weakening of the concrete by retained water. Cracks 2mm wide were observed on some piers below the level normally submerged in water. The team concluded this happened as a result of poor concrete mix during construction of the piers, resulting in thermal cracks to occur. Lastly, some pile caps are also exposed and vulnerable to scouring.

Figure 15. Formwork observed under deck.

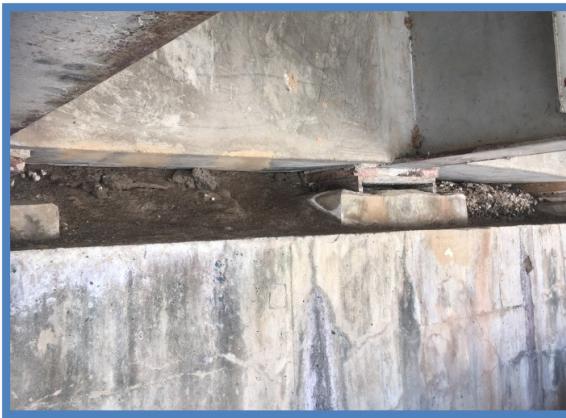
The Bridge at Dindima is a composite bridge built with reinforced concrete deck, piers, pier caps, pile caps and abutments, and steel I girders. The Gongola River flows under this bridge. At Dindima the team of engineers noted that the fixed bearings on the approach abutment from Bauchi State have all failed. The elastomers have split and are extruding, bearing alignment and load carrying capacity may be beyond limits and the shear keys have failed. It was also observed that overtime; back fill has been seeping from underneath the bituminous roadway approach through the expansion joint to the bearing seat of the abutment. This has resulted in shear cracks 3mm wide on the beam supporting the approach and obvious settlement of the slab. The locals in the area have casted concrete on the bearing seat of the abutment in an attempt to stop further soil loss from the backfill which would cause the bridge to separate entirely from the existing road eventually. Fig. 16

Figure 17.Soil loss from roadway approach.

10. Reconstruction of the failing bituminous roadway approach from Bauchi for the Dindima Bridge.
11. Repair, resetting or replacement of ageing or faulty bearings where necessary.
12. Repainting of the steel girders for the composite girder bridges to increase protection against weathering effects.
13. Lastly, for the Kwadon / Liji /Kurba Bridge, it needs to be reconstructed as it has failed and has been sealed off to general traffic due to safety concerns. It is advised that a reputable construction company is awarded the contract.

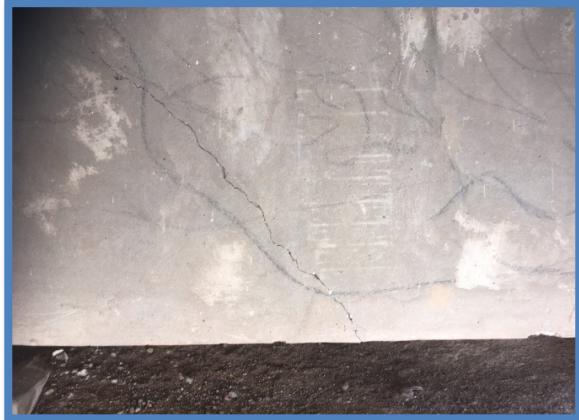
Figure 18.3mm wide crack on approach beam

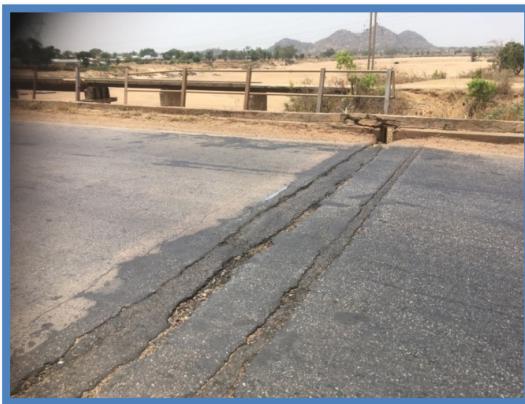
Figure 19.Spalling on approach joint.**Figure 20.**Missing railings due to vandalism.

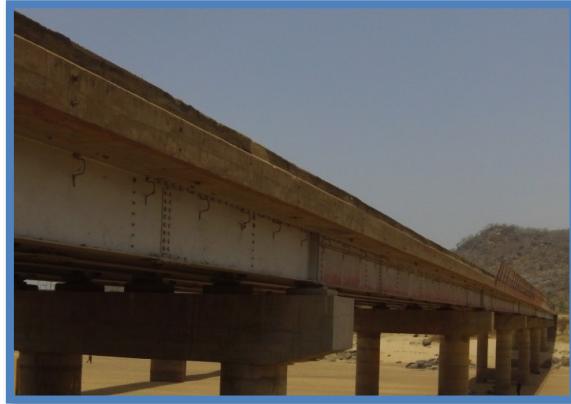
The team also noted that a lot of steel pipe bridge railings were missing, removed by vandals. This has left long distances along the bridge unprotected by any sort of barrier. Shrubs were found to have grown on the bearing seats due to accumulation of debris. It was observed that the channel bed had eroded and this has left some of the pile caps vulnerable to scouring.

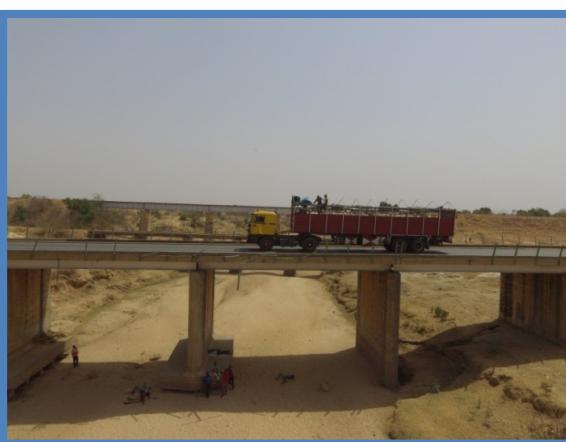
The bridge at Gwaram is a composite bridge with the deck, piers, pier caps, pile caps and abutments all made of reinforced concrete while the girders are steel I girders. On this bridge, the team observed that there was barely any form of protective barriers left. The aluminum bridge railings were all missing either due to impact damage from road accidents or vandalism. This can be seen in figure 22.

Figure 22.Noticeable absence of railings.

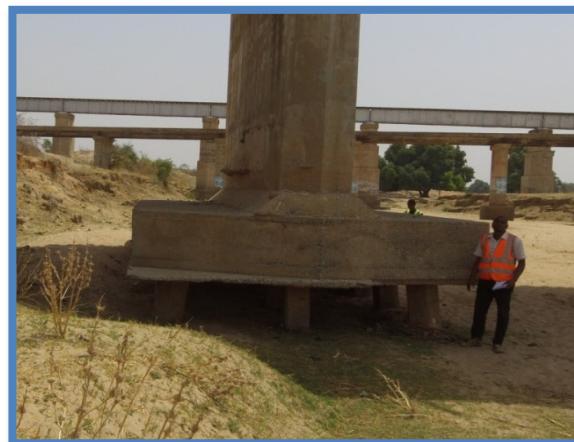
Further inspection revealed that the channel bed has undergone serious erosion and some pile caps and numerous piles have been left exposed and are undergoing weathering as seen in figure 23. The team concluded that the piers with exposed piles have reduced support capacity and pose a threat to the structural integrity of the bridge as a whole. This is a potential hazard that could result in loss of lives and property.

Figure 23.Exposed pile caps and piles

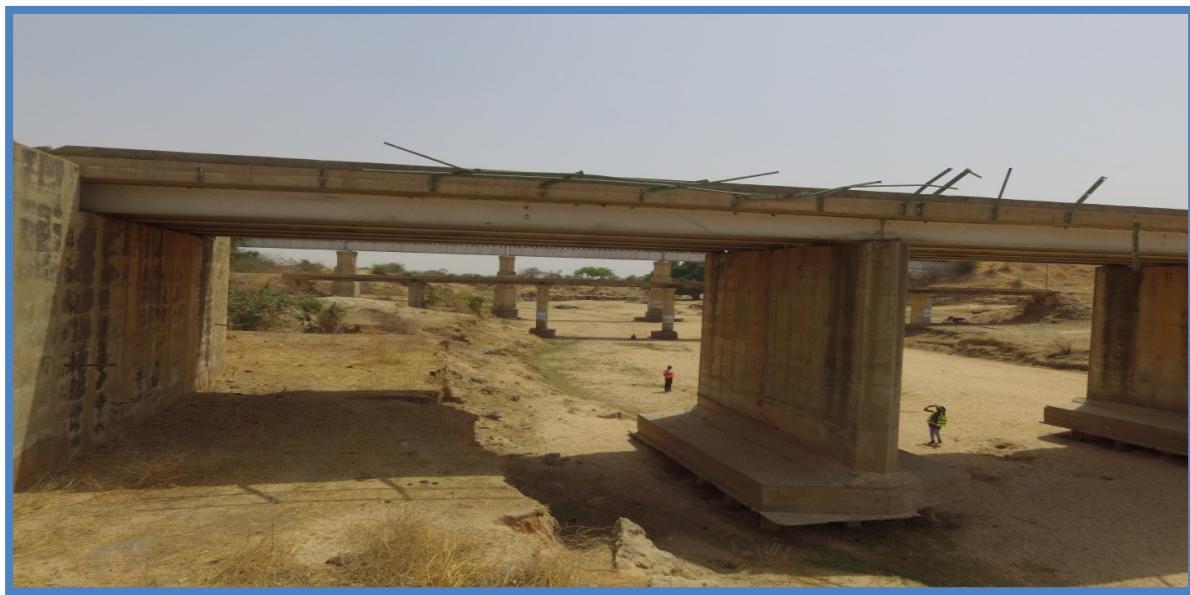
Figure 24. Major loss of channel bed to erosion and scouring. **Source: Field Survey 2019**

In conclusion, the Gwaram bridge needs immediate preventive maintenance in order to ensure the safety of road users and property along this route and also to preserve and extend the useful life of the bridge.

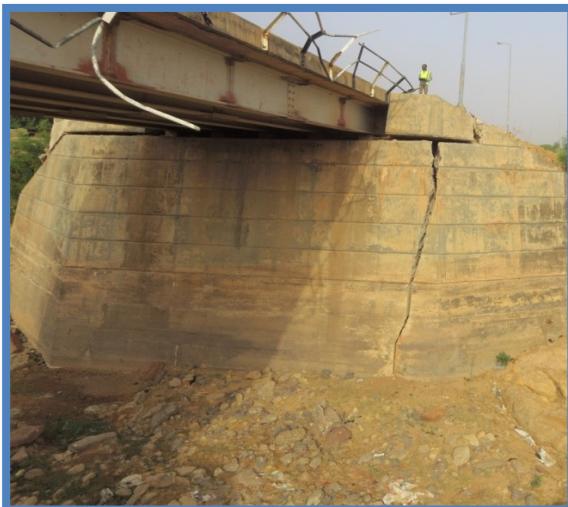
This bridge is located along Gombe-Biu road. The main construction materials are concrete and steel. It has been shut off to general traffic due to its deplorable condition. The abutment from the Gombe approach has literally broken in two directions; horizontally and vertically as seen in figure 26. The team observed that no reinforcements were used in the construction of the abutment: it was just a big mass of concrete with inadequate tensile resistance to loading. The contractor erroneously designed the abutment to be over 1 metre thick, thinking it sufficient to carry out its functions. This can be seen in figure 27.

Figure 26. Major cracks on abutment.

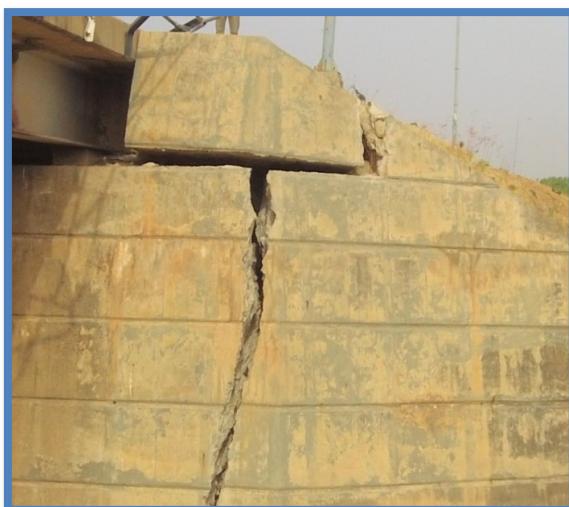
Figure 27. Absence of rebars in abutment.

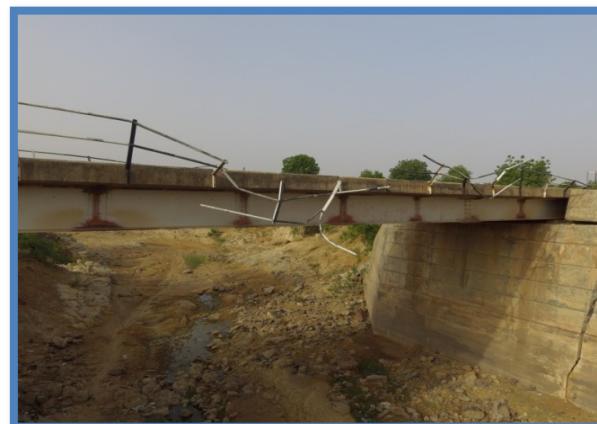
Also, no form of protection had been applied to the embankment after construction. The soil behind the wing wall has been greatly eroded by water from the highway drainage emptying directly behind the wing wall. This erosion has eaten underneath the approach slab and caused noticeable settlement as one approaches the bridge. In an attempt to stop the backfill erosion, boulders have been dumped behind the wing wall as an afterthought. This action has resulted in further differential settlement of the approach slab.

Figure 28. Poor attempt to arrest backfill loss.
