Comparative study of the road roughness measurement of Roadlab Pro and Roadroid applications for IRI data collection in Nigeria

Comparative Study of the Road Roughness Measurement of Roadlab Pro and Roadroid Applications for IRI Data Collection in Nigeria

¹Ekpenyong, E.E., ¹Abu, A.S.P., ²Cinfwat, K.Z.,

¹ Nigerian Building and Road Research Institute, Abuja Nigeria

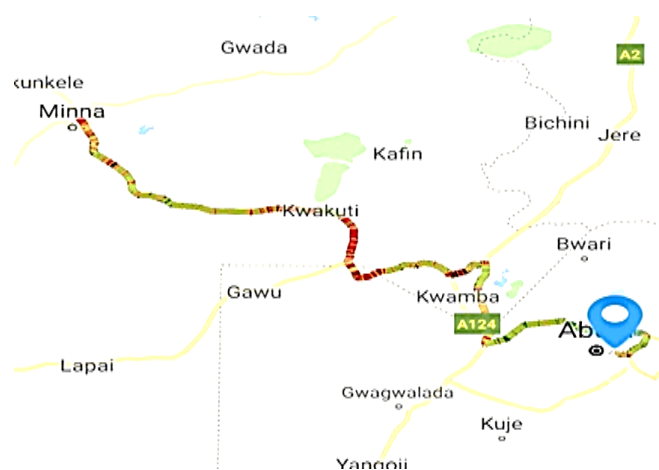
From data collected by RoadLab Pro, the total surveyed length is 313.17km with an average speed of 74.38km/h. Roughness measurement from the application showed that 98.35% of total surveyed length was recorded while 1.65% of total survey length was not recorded due to vehicle speed dropping below minimum required speed required to capture data (World Bank, 2017). The average IRI recorded based on the roughness measured is 4.48; classified as fair as indicated in Table 1. Results also show that road sections with fair IRI values were the most prevalent in terms of partial or complete road failure. Visualisation of the IRI measurement for the route from the RoadLab Pro is shown in Figure 1.

Figure 1: Screenshot of IRI measurement for road link (RoadLab Pro)

From data analysed, there is a 2% and 2.6% error margin of the total surveyed length and average speed for the road link. It is also observed that each road section surveyed in clockwise and counter clockwise direction falls within, 0.02% to 0.48% error margin except for the section of road with severe pavement deterioration (Lambata to Minna) in clockwise and counter clockwise direction with error margin of 4.80% (3.32km) and 4.91% (4.14km) error margin. This section has the longest length without roughness or road length recorded by RoadLab Pro; implying that the reliant on accelerometers as primary roughness sensors may not detect roughness index on certain road failure conditions. Also, the IRI values for both applications are classified in different IRI condition category seen in the road condition result and map interpretation guide in Table 1 and Table 2.

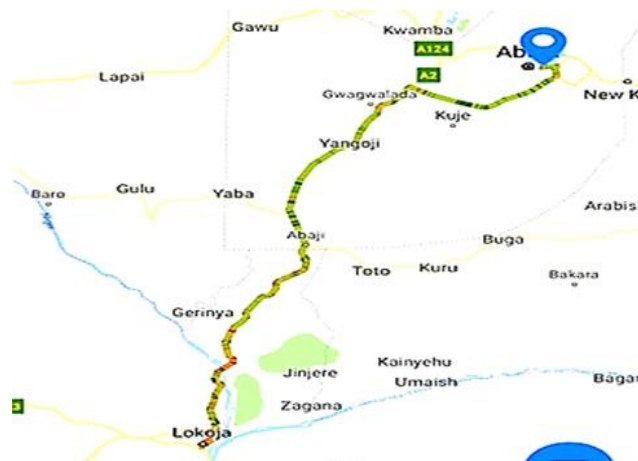
From data collected by RoadLab Pro, total surveyed length is 392.25km with average speed of 87.91km/h. 99.74% of the total survey length recorded an average IRI of 3.13; classified as good. Most section of the road link recorded IRI values classified as good as seen in Figure 2 where significant section of the route link is within the green colour range.

Figure 2: Screenshot of IRI measurement for road link (RoadLab Pro)

From both data collected, there is a 0.008% and 0.58% error margin of the total surveyed length and average speed of road link in clockwise and counter clockwise direction. From visual observation, this route has the longest road link with severe rutting with total surveyed length of about 0.03km. This may mean that the sensors can detect roughness on pavement surface with rut. Also, IRI values for both applications are captured within similar condition category as seen in Table 1 and Table 2.
